Monitoring for success in stream restoration: a case study of the Kama Creek, north shore of Lake Superior

**MONITORING FOR SUCCESS IN STREAM RESTORATION: A CASE STUDY OF
THE KAMA CREEK, NORTH SHORE OF LAKE SUPERIOR**

A Thesis Submitted to Lakehead University in Partial Fulfillment of the
Thesis requirements for the degree of
Master of Environmental Studies in Northern Environments and Cultures
in the departments
of
Anthropology and Geography

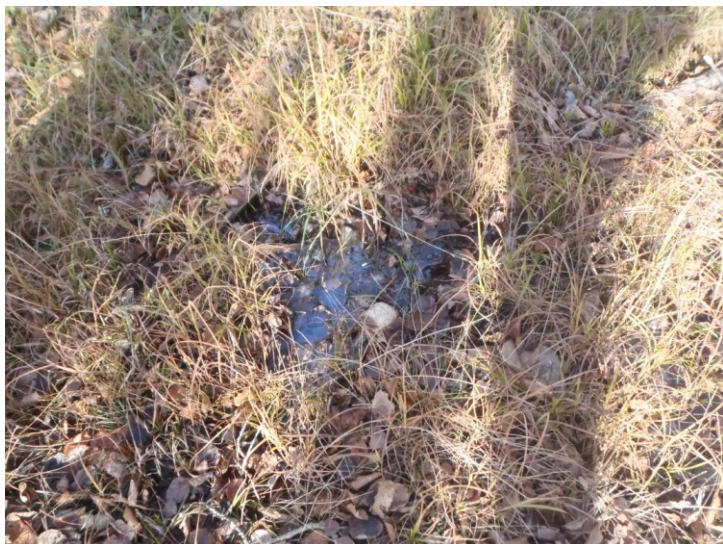
Figure 4.2a Groundwater seep located on the bank of newly restored reach of Kama Creek.

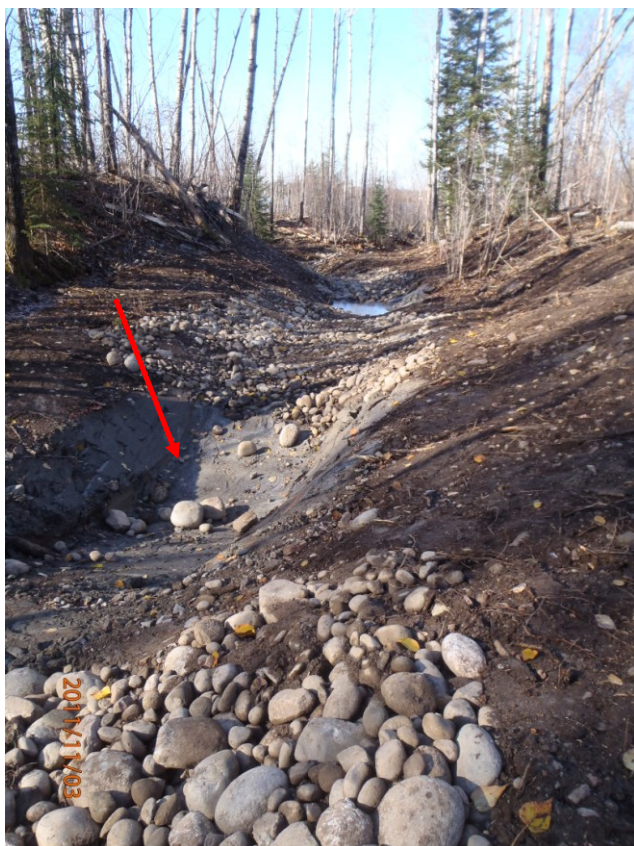
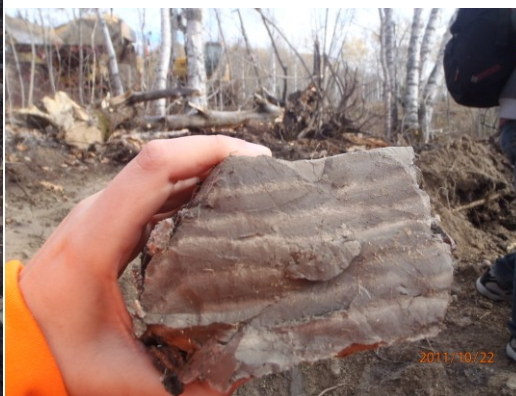
Figure 4.2b and c. Photos of clay bottom found when excavating reach 2 of Kama Creek. Arrow points to thick clay layer in pool of new channel (left). On the right, section of clay showing layering.

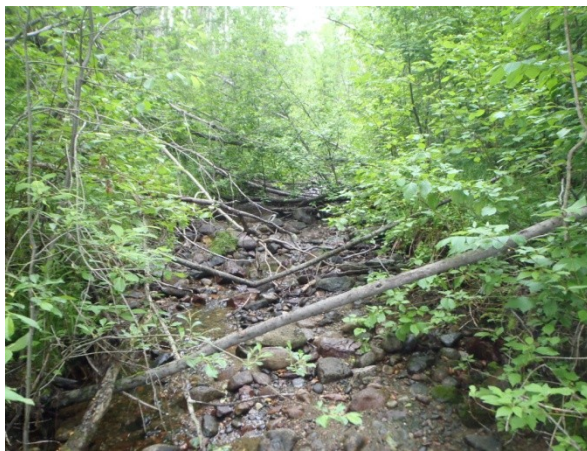
In 2011, reach 1 showed an optimal amount of available cover with many fallen logs and large woody debris (Figure 4.3a). It was given a rating of 20 for most optimal epifaunal substrate and available cover (Table 4.1) because greater than 50% of the substrate was favorable for epifaunal colonization and fish cover. In 2012 the newly restored channel (reach 2) was rated as poor conditions for available cover. This was due to a lack of cover directly after construction (Figure 4.3b). In 2014, reach 2 established a variety of natural structures in the stream, such as cobble (riffles), large rocks, fallen trees, logs and branches, and undercut banks. These features provide refugia, feeding sites, and sites for spawning and nursery from the establishment of aquatic macrofauna (Figure 4.3c). These factors increased the rating to 11 at the low end of suboptimal habitat.

Figure 4.3a. Reach 1 Showing optimal cover in 2011. Figure 4.3b. Reach 2 2012 showing minimal cover

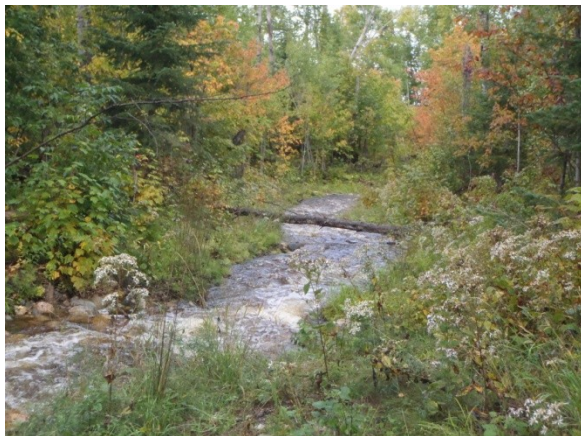
Figure 4.3c. Reach 2 in 2014 showing improvements in cover compared to 2012.

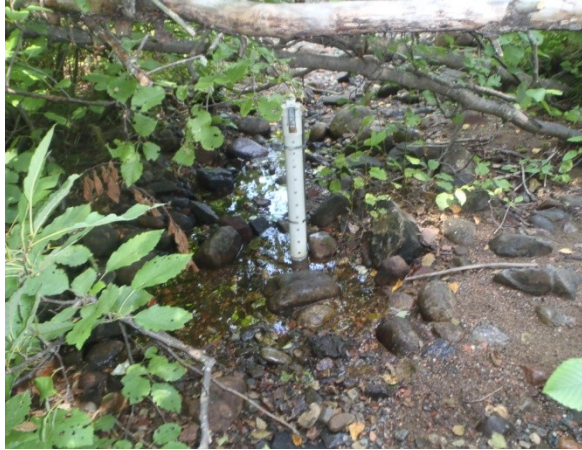
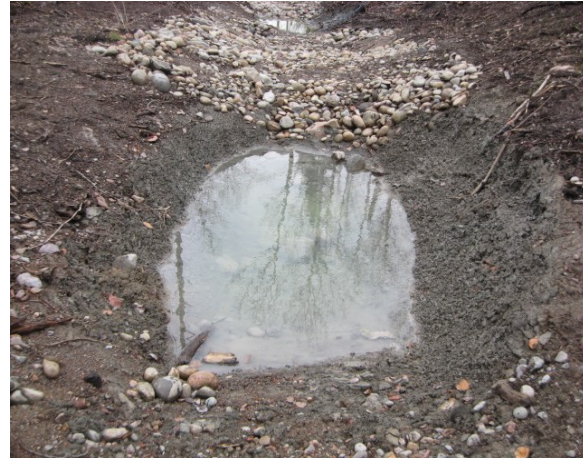
Figure 4.4a. Reach 1 in 2011 showing optimal substrate. Figure 4.4b. Reach 2 in 2012 showing poor Substrate with mud and clay dominant And no submerged vegetation.

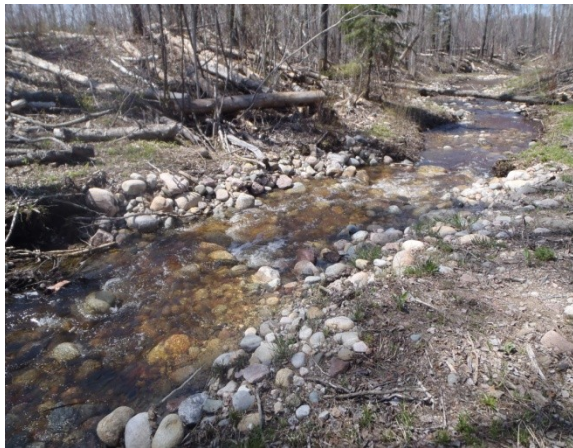
Figure 4.4c. Reach 2 in 2014 showing slight improvements in pool substrate characterization.

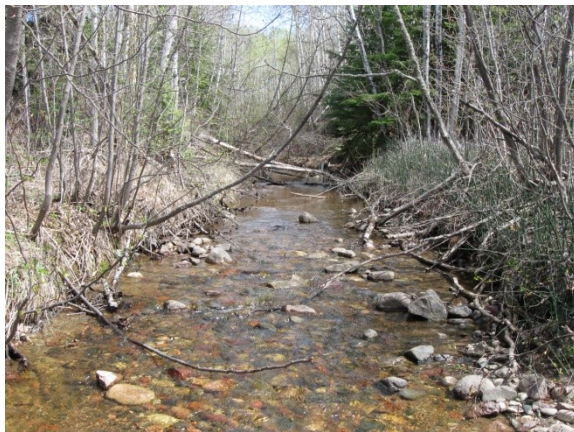
Figure 4.8a. Marginal in the old channel in 2011 with few shallow pools present.

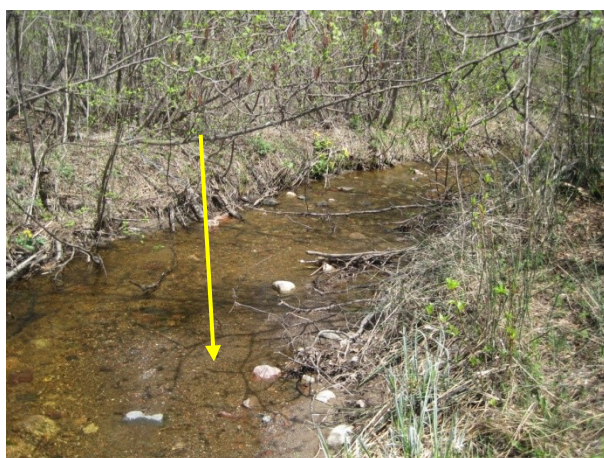
Figure 4.9a. Arrow shows sediment deposition in old channel in 2011

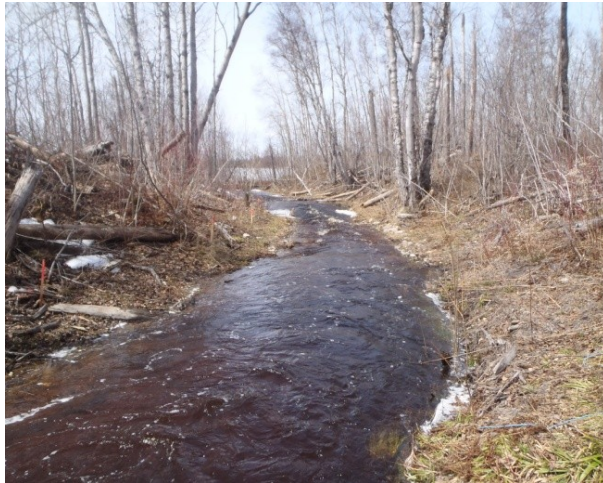
Figure 4.9c. Reach 2 in 2014 starting to show sediment deposition

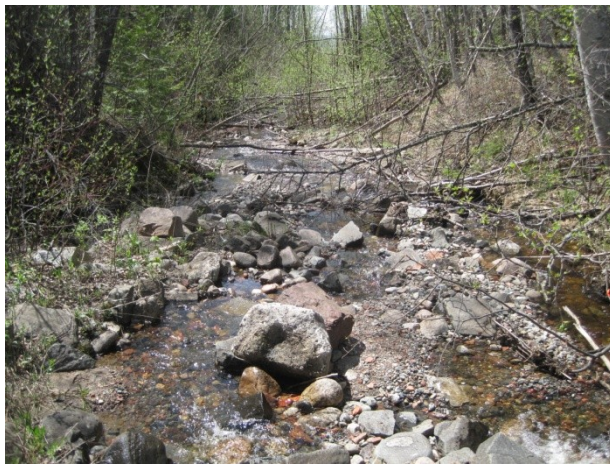
Figure 4.10a. 2011 Marginal channel flow status

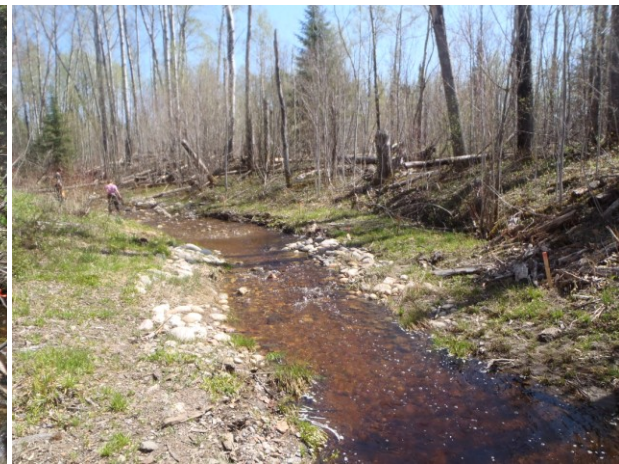
Figure 4.10b. 2014 suboptimal channel flow status

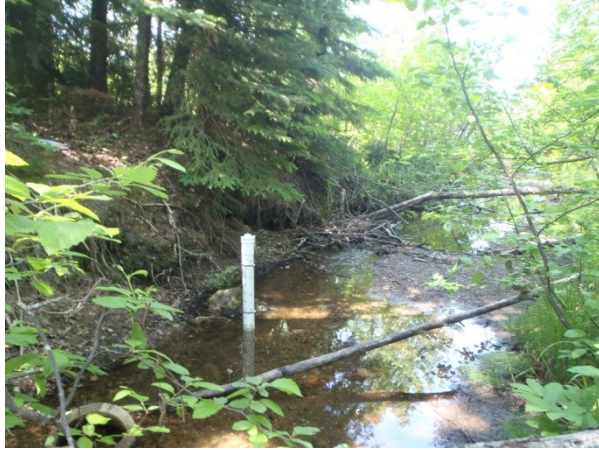
Figure 4.14a. 2011 old channel showing steep eroded banks.

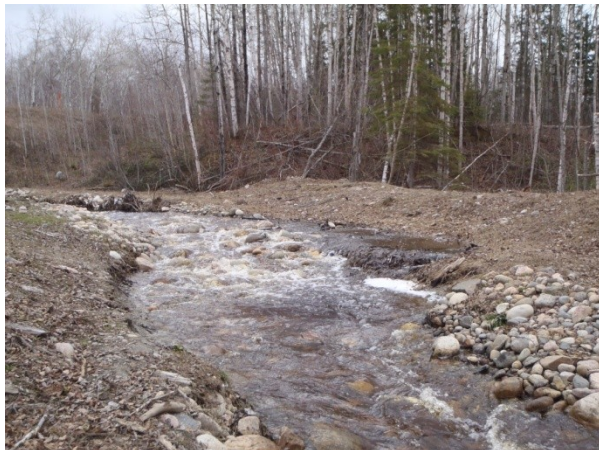
Figure 4.14c. 2014 new channel showing erosion of banks.

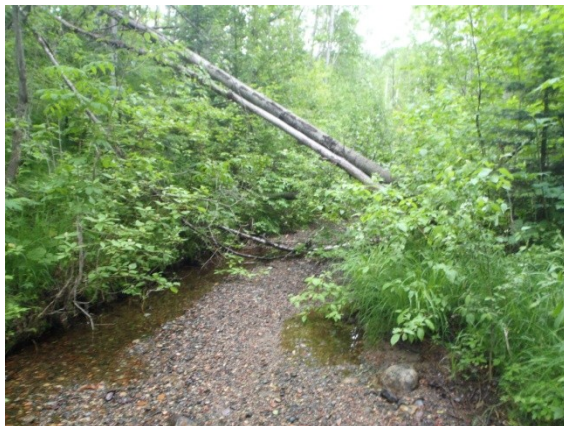
Figure 4.15a. Photo shows optimal vegetation in 2011. Figure 4.15b. In 2012 vegetation not yet grown.

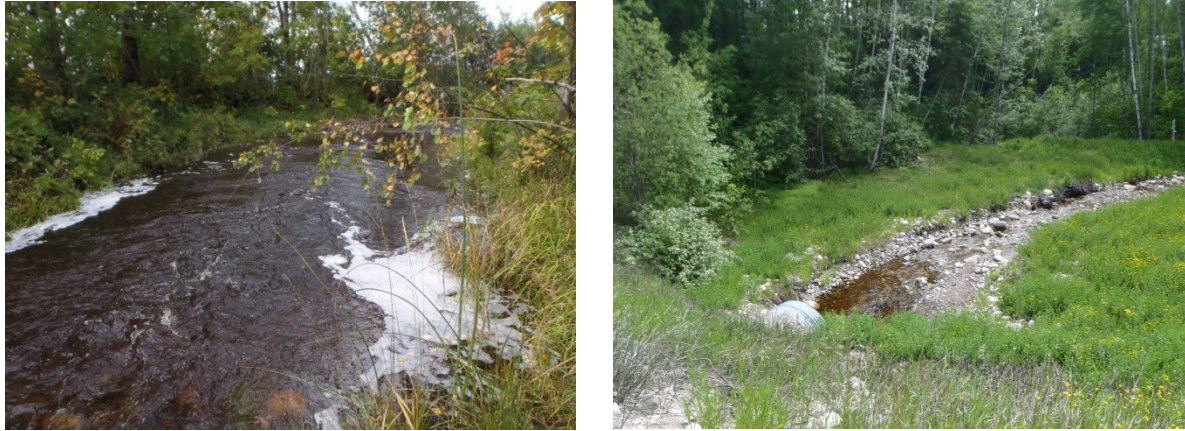
Figure 4.15c. and d. By 2014 vegetation has already grown thick along bank of new channel.

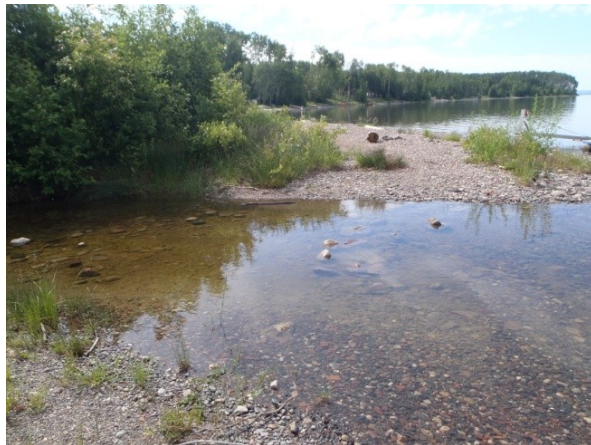
Figure 4.16a. Cabins along the shore are affecting the riparian zone.
